**Flood Control Project Maintenance  
Levee Inspections**

**Fall 2013 Levee Maintenance Deficiency Summary Report**

**San Joaquin River Basin**

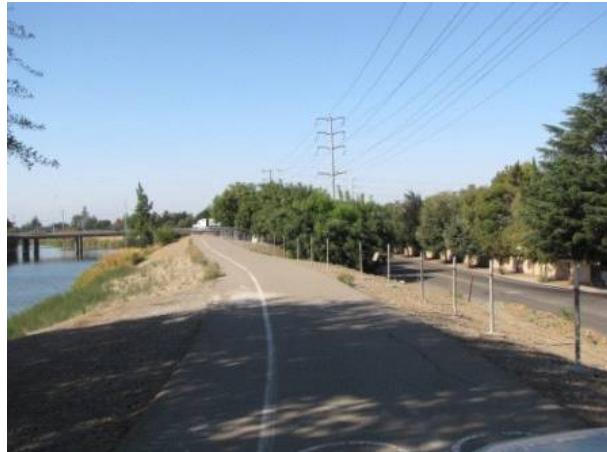
Levee Mile Report Line	159
Start Levee Mile	23.54
End Levee Mile	23.69
Location	Land Side
Category	Earthen Levee
Item	Encroachments
View of a fence along landward shoulder looking downstream.	
<i>pkazi_f_20131001_388.jpg</i>

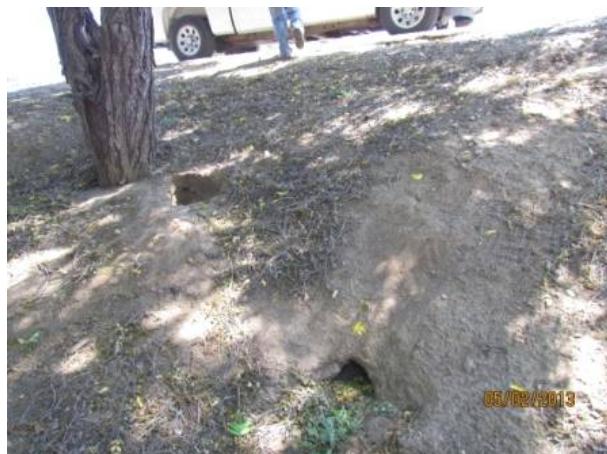
Levee Mile Report Line	160
Start Levee Mile	23.61
End Levee Mile	23.61
Location	Land Side
Category	Earthen Levee
Item	Animal Control
An animal hole was found on the landside slope of the levee looking upstream.	
<i>pkazi_f_20131001_343.JPG</i>

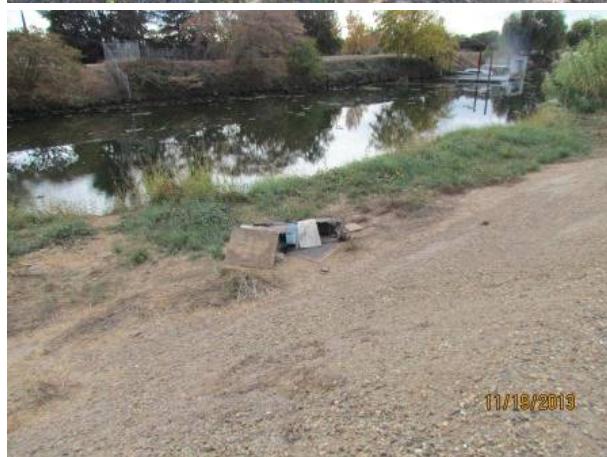
Levee Mile Report Line	161
Start Levee Mile	23.80
End Levee Mile	23.80
Location	Water Side
Category	Earthen Levee
Item	Encroachments
Debris was found on the waterside toe of the levee looking downstream.	
<i>pkazi_f_20131119_068.JPG</i>

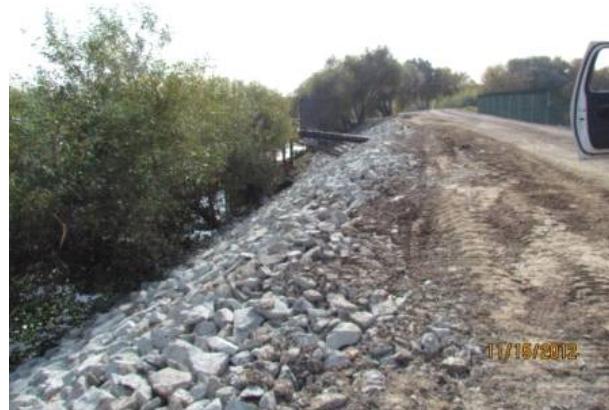
Levee Mile Report Line	163
Start Levee Mile	24.18
End Levee Mile	24.18
Location	Water Side
Category	Earthen Levee
Item	Riprap Revetments
Revetment was placed by the LMA on the waterside slope of the levee looking downstream.	pkazi_f_20131001_365.jpg

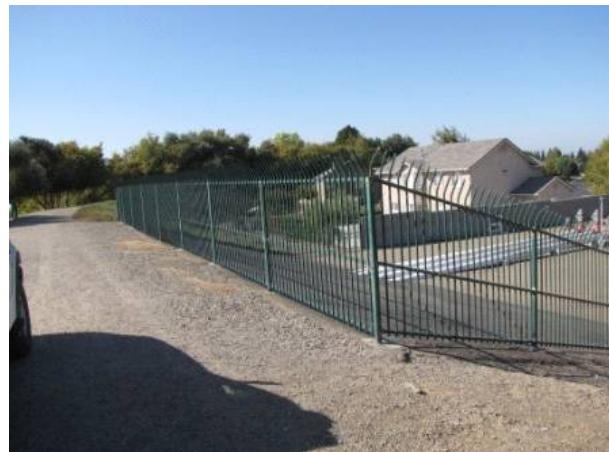
Levee Mile Report Line	164
Start Levee Mile	24.20
End Levee Mile	24.21
Location	Land Side
Category	Earthen Levee
Item	Encroachments
View of fence along the landward shoulder looking downstream.	pkazi_f_20131001_389.jpg

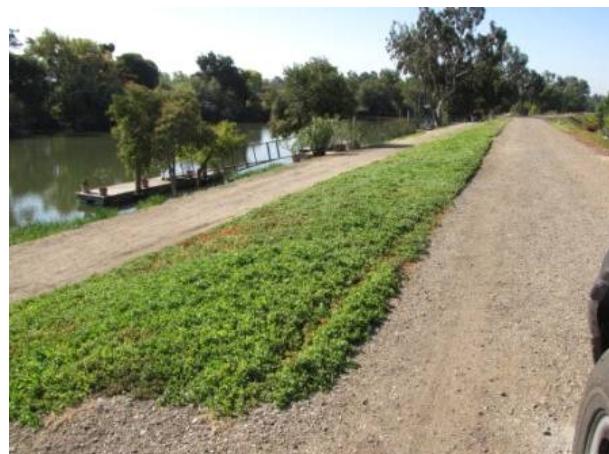
Levee Mile Report Line	165
Start Levee Mile	24.65
End Levee Mile	25.59
Location	Water Side
Category	Earthen Levee
Item	Vegetation
View of typical landowner planted and maintained landscaping and irrigation along the waterward shoulder and slope looking downstream.	pkazi_f_20131001_390.jpg

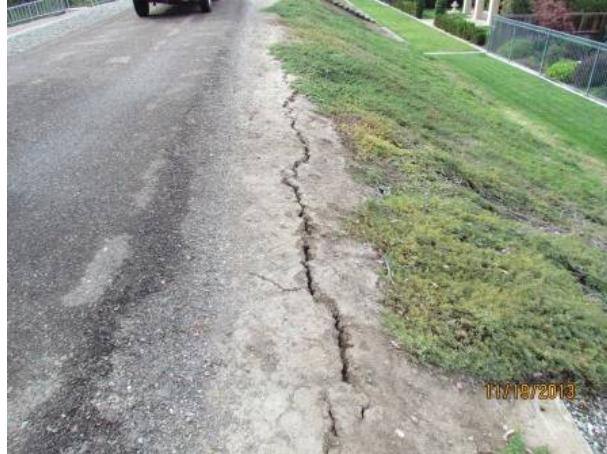
Levee Mile Report Line	166
Start Levee Mile	24.78
End Levee Mile	24.90
Location	Land Side
Category	Earthen Levee
Item	Cracking
A crack was found on the landside shoulder of the levee looking downstream during fall 2013 inspection.	
pkazi_f_20131119_069.JPG

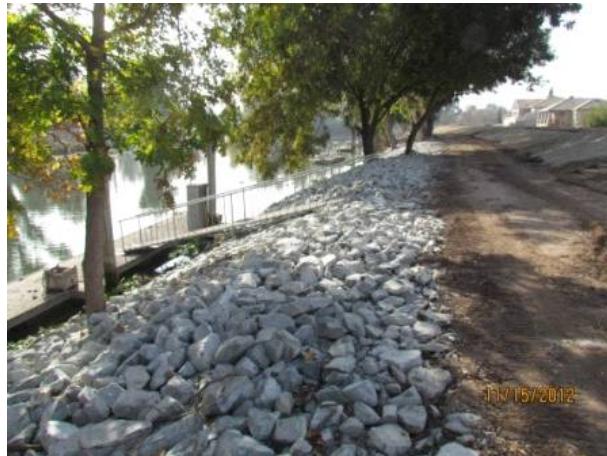
Levee Mile Report Line	167
Start Levee Mile	24.84
End Levee Mile	24.84
Location	Water Side
Category	Earthen Levee
Item	Riprap Revetments
Rvetments were placed by the LMA on the waterside slope of the levee looking downstream.	
pkazi_f_20131001_366.jpg

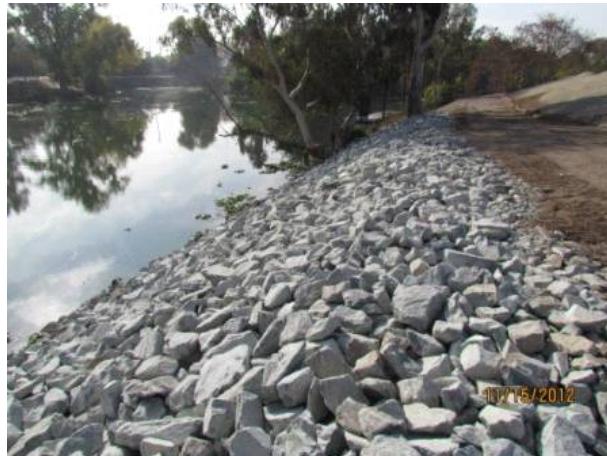
Levee Mile Report Line	175
Start Levee Mile	25.00
End Levee Mile	25.00
Location	Water Side
Category	Earthen Levee
Item	Riprap Revetments
Rvetments were placed by the LMA on the waterside slope of the levee looking downstream.	
pkazi_f_20131001_367.jpg

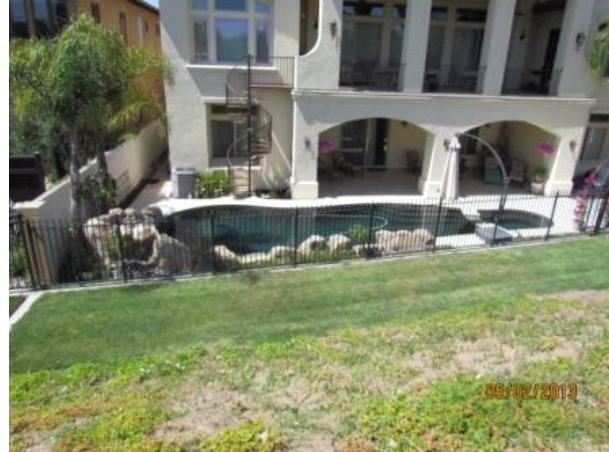
Levee Mile Report Line	179
Start Levee Mile	25.35
End Levee Mile	25.35
Location	Land Side
Category	Earthen Levee
Item	Encroachments
A pool was found on the landside toe of the levee looking downstream.	
pkazi_f_20131001_298.JPG

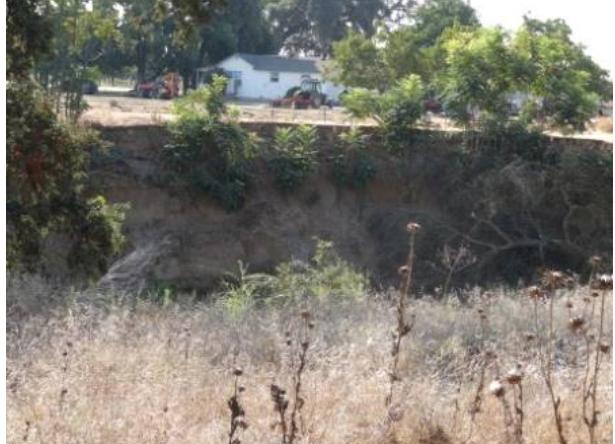
SJR2013_NA0017U16RM23.35_1.jpg

Levee Mile Report Line	3
Start Levee Mile	0.13
End Levee Mile	0.47
Location	Water Side
Category	Supplemental
Item	DWR Erosion Survey
Front view of erosion. Looking from the right side of the river.

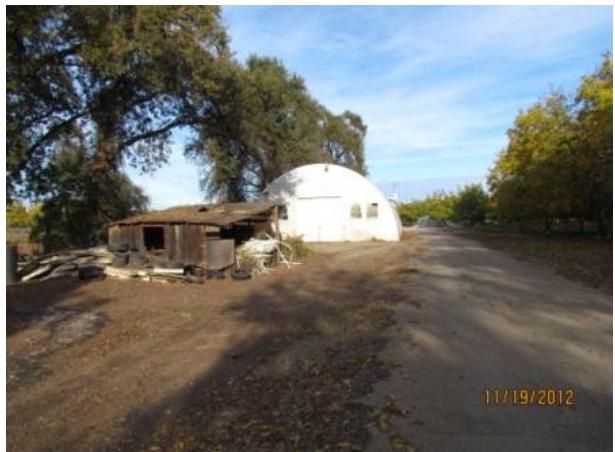
pkazi_f_20131001_447.jpg

Levee Mile Report Line	5
Start Levee Mile	0.54
End Levee Mile	0.54
Location	Water Side
Category	Earthen Levee
Item	Encroachments
A building was located on the waterside shoulder of the levee looking upstream.

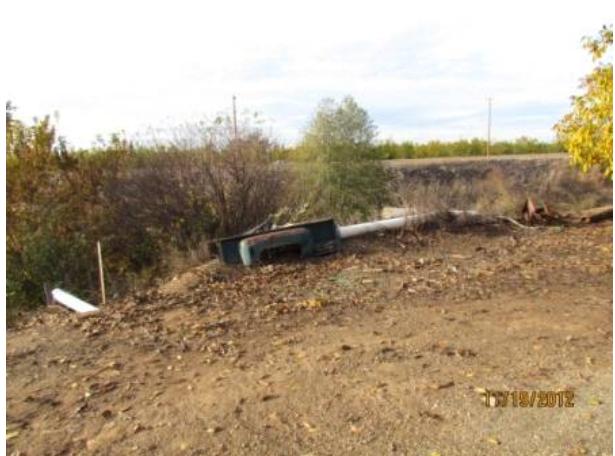
pkazi_f_20131001_446.jpg

Levee Mile Report Line	7
Start Levee Mile	0.81
End Levee Mile	0.81
Location	Water Side
Category	Earthen Levee
Item	Encroachments
Debris was found on the waterside shoulder of the levee looking upstream.

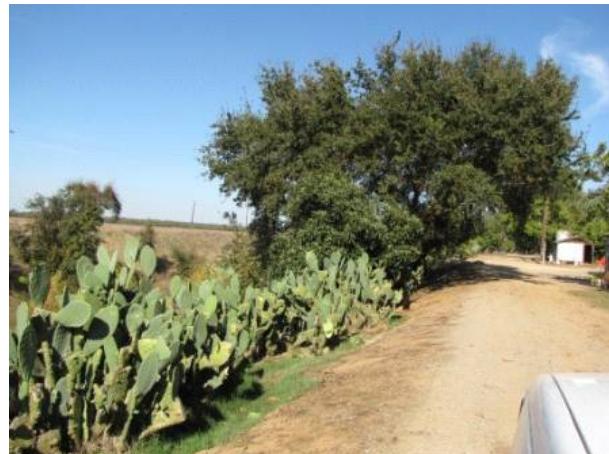
pkazi\_f\_20131001\_504.jpg

View of landowner maintained landscaping on waterward side looking upstream.

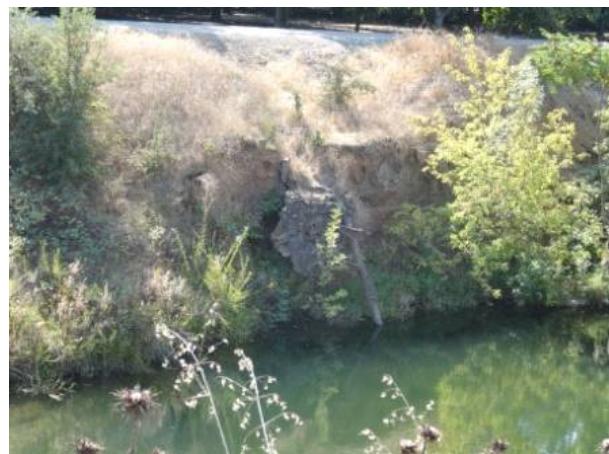
SJR2013\_NA0017U16RM22.74\_2.jpg

Waterway							Bank	Unit Miles	Inspection Start/End	Inspector	
LMR No.	Levee Mile		Category	Item	* Location	** Rating	Action/Comment			GPS Latitude/Longitude	Issue No.
	Start	End					Start	End	Photo		
10	0.97	0.99	Supplemental DWR Erosion Survey	DWR Erosion Survey	WS	U Ma	Inspector Comments: 09/12/2013: No significant changes observed. 08/22/2012: The erosion was surveyed and documented for monitoring purpose. There is no levee structure on the site, only high ground protecting the land behind. The levee crest width and levee height were not measured or estimated in the field. There is a drainage pipe at the site, which might have caused the problem at one pocket erosion. [2013 Site ID:NA0017U16RM22.74]	38.043080 ° -121.026280 °	38.043080 ° -121.026280 °	157 Y	DWR ID:
11	1.13	1.13	Supplemental DWR Erosion Survey	DWR Erosion Survey	WS	U Ma	Inspector Comments: 9/12/2013: No significant changes observed. 08/22/2012: Erosion is at the outside corner of a river bend, and next to a tree at the levee toe. Irrigation structure presents at the site. There is no levee structure on site. The levee crest width and levee height were not measured or estimated in the field. [2013 Site ID:NA0017U16RM22.58]	38.041260 ° -121.027730 °	38.041260 ° -121.027730 °	163 Y	DWR ID:

Levee Mile Report Line	10
Start Levee Mile	0.97
End Levee Mile	0.99
Location	Water Side
Category	Supplemental
Item	DWR Erosion Survey

Front view of erosion.

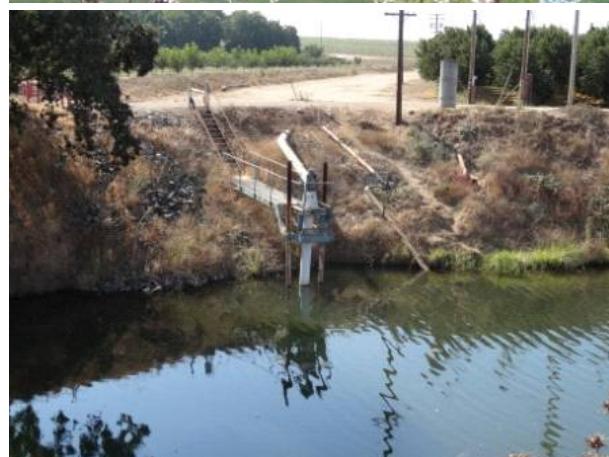
SJR2013\_NA0017U16RM22.58\_2.jpg

Levee Mile Report Line	11
Start Levee Mile	1.13
End Levee Mile	1.13
Location	Water Side
Category	Supplemental
Item	DWR Erosion Survey

Front view of erosion. Note the irrigation pipe at the erosion site.

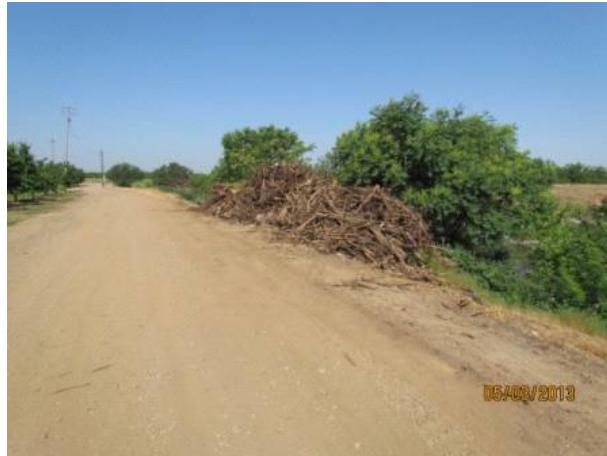
Levee Mile Report Line	13
Start Levee Mile	1.48
End Levee Mile	1.48
Location	Water Side
Category	Earthen Levee
Item	Encroachments
Prunings were found on the waterside shoulder of the levee looking downstream.	
pkazi_f_20131001_438.JPG

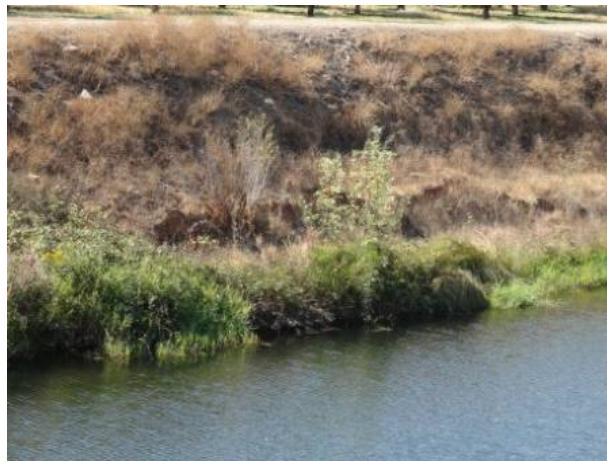
Levee Mile Report Line	14
Start Levee Mile	1.59
End Levee Mile	1.59
Location	Water Side
Category	Supplemental
Item	DWR Erosion Survey
Close view at the erosion.	
SJR2013_NA0017U16RM22.15_2.jpg

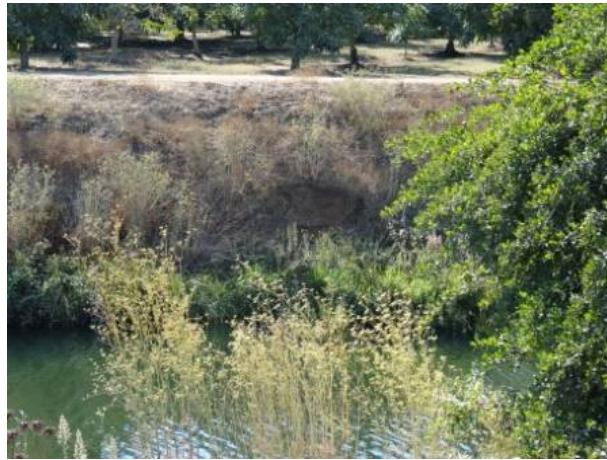
Levee Mile Report Line	15
Start Levee Mile	1.74
End Levee Mile	1.75
Location	Water Side
Category	Supplemental
Item	DWR Erosion Survey
Front view of the pocket erosion.	
SJR2013_NA0017U16RM22.01_2.jpg

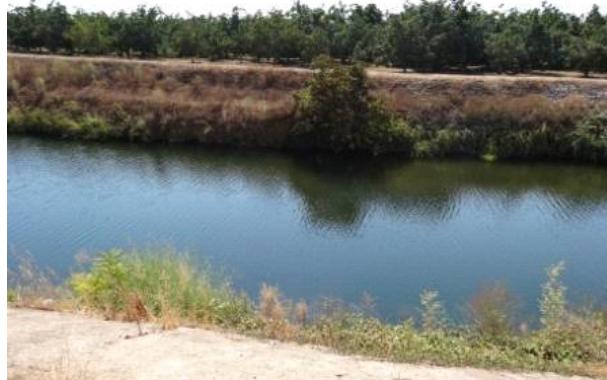
SJR2013\_NA0017U16RM21.95\_1.jpg

16	1.75	1.76	Supplemental DWR Erosion Survey	DWR Erosion Survey	WS	M Ma	Inspector Comments: 9/12/2013: No significant changes observed. 08/22/2012: Erosion is covered by dense vegetation. There is no levee structure on site. The levee crest width and levee height were not measured or estimated in the field. [2013 Site ID:NA0017U16RM21.95]	38.038080 ° -121.038676 °	38.038080 ° -121.038676 °	166 Y	DWR ID:

Levee Mile Report Line	16
Start Levee Mile	1.75
End Levee Mile	1.76
Location	Water Side
Category	Supplemental
Item	DWR Erosion Survey

Front view of erosion site.

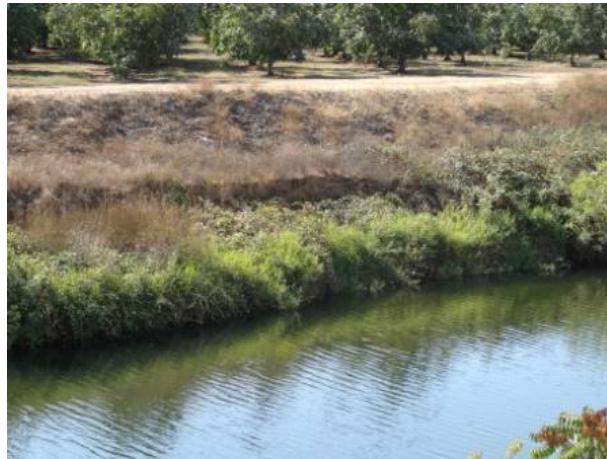
SJR2013\_NA0017U16RM21.94\_1.jpg

Waterway							Bank	Unit Miles	Inspection Start/End	Inspector		
LMR No.	Levee Mile		Category	Item	* Location	** Rating	Action/Comment			GPS Latitude/Longitude	Issue No.	
	Start	End					Start	End	Photo			
17	1.77	1.78	Supplemental DWR Erosion Survey	WS M	Ma		Inspector Comments: 9/12/2013: No significant changes observed. 08/22/2012: Site is covered by dense vegetation. Berm width is estimated as 5 ft. There is no levee structure on site. The levee crest width and levee height were not measured or estimated in the field. [2013 Site ID:NA0017U16RM21.94]	38.037906 °	38.037906 °	168 -121.038949 °	-121.038949 ° Y	
										DWR ID:		
18	1.93	1.95	Supplemental DWR Erosion Survey	WS M	Ma		Inspector Comments: 9/12/2013: No significant changes observed. 08/22/2012: Berm width is estimated as 5 ft. There is no levee structure on site. The levee crest width and levee height were not measured or estimated in the field. [2013 Site ID:NA0017U16RM21.05]	38.037150 °	38.037150 °	169 -121.040580 °	-121.040580 ° Y

Levee Mile Report Line	17
Start Levee Mile	1.77
End Levee Mile	1.78
Location	Water Side
Category	Supplemental
Item	DWR Erosion Survey

Looking downstream at the erosion.

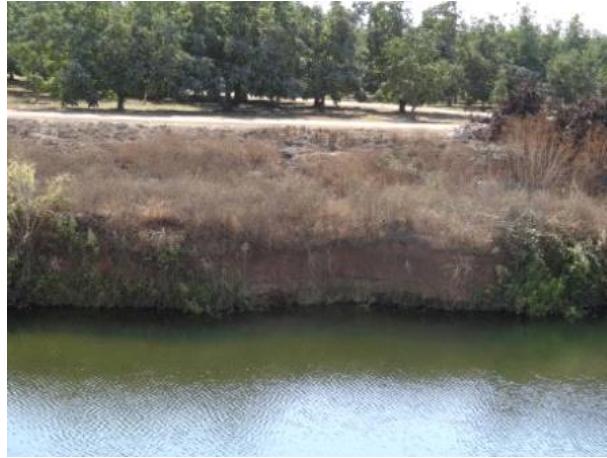
SJR2013\_NA0017U16RM21.05\_3.jpg

Levee Mile Report Line	18
Start Levee Mile	1.93
End Levee Mile	1.95
Location	Water Side
Category	Supplemental
Item	DWR Erosion Survey

Front view of the erosion.

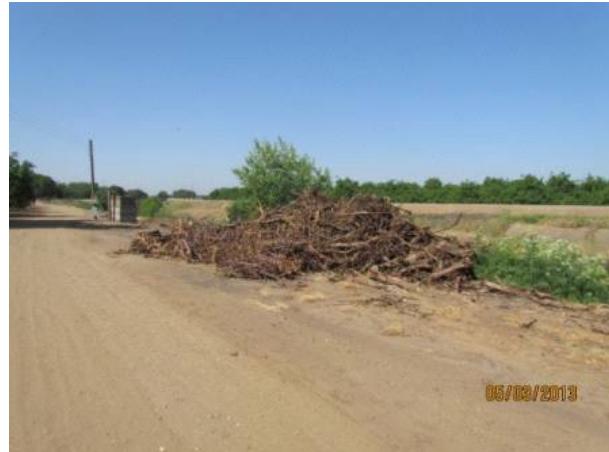
Levee Mile Report Line	20
Start Levee Mile	1.95
End Levee Mile	1.95
Location	Water Side
Category	Earthen Levee
Item	Encroachments
Prunings were found on the waterside shoulder of the levee looking downstream.	
pkazi_f_20131001_398.JPG

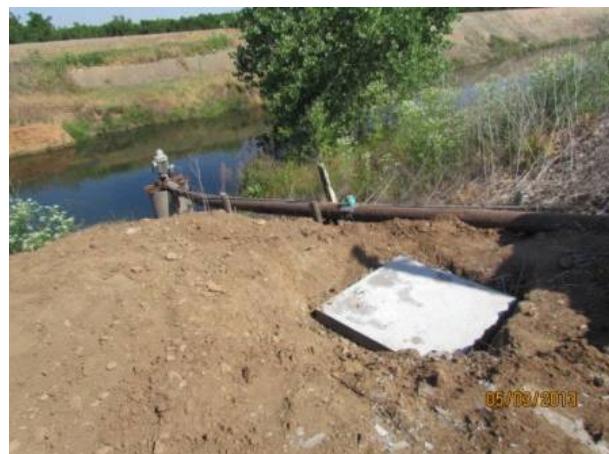
Levee Mile Report Line	21
Start Levee Mile	1.95
End Levee Mile	1.95
Location	Water Side
Category	Earthen Levee
Item	Encroachments
A concrete pad was found on the waterside shoulder of the levee looking upstream.	
pkazi_f_20131001_395.JPG

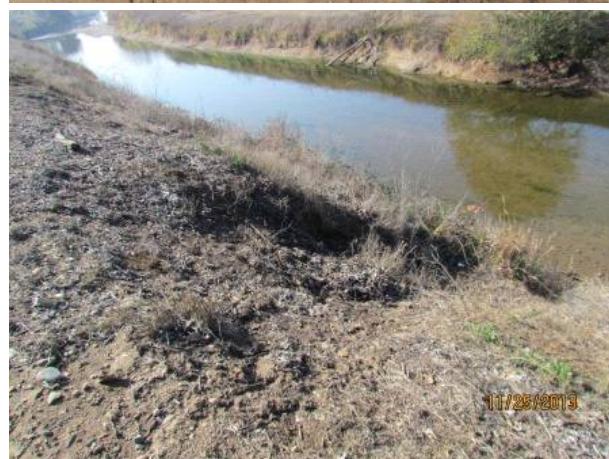
Levee Mile Report Line	22
Start Levee Mile	1.97
End Levee Mile	1.97
Location	Water Side
Category	Earthen Levee
Item	Erosion / Bank Caving
Erosion was found on the waterside of the levee looking downstream.	
pkazi_f_20131126_095.JPG

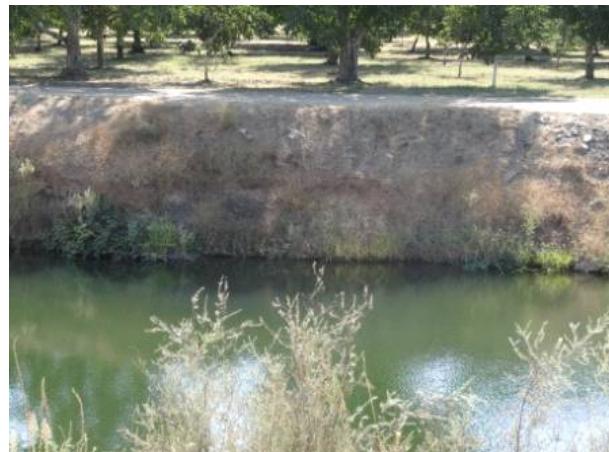
Levee Mile Report Line	25
Start Levee Mile	2.37
End Levee Mile	2.38
Location	Water Side
Category	Supplemental
Item	DWR Erosion Survey
Close view of erosion. Note the vegetation at the site.	
SJR2013_NA0017U16RM20.62_2.jpg

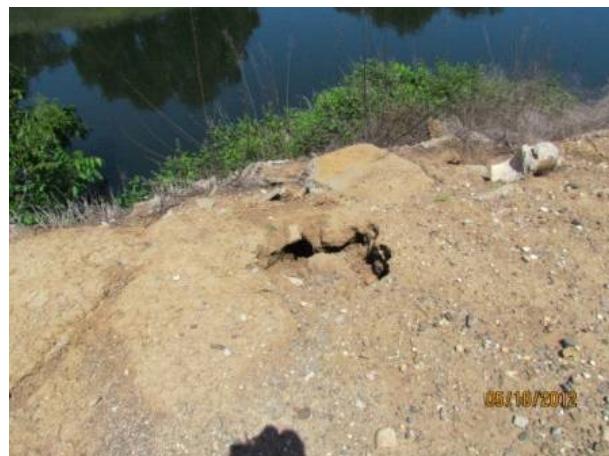
Levee Mile Report Line	27
Start Levee Mile	2.42
End Levee Mile	2.42
Location	Water Side
Category	Earthen Levee
Item	Slope Stability
Slope instability was found on the waterside of the levee looking upstream.	
pkazi_f_20131001_517.jpg

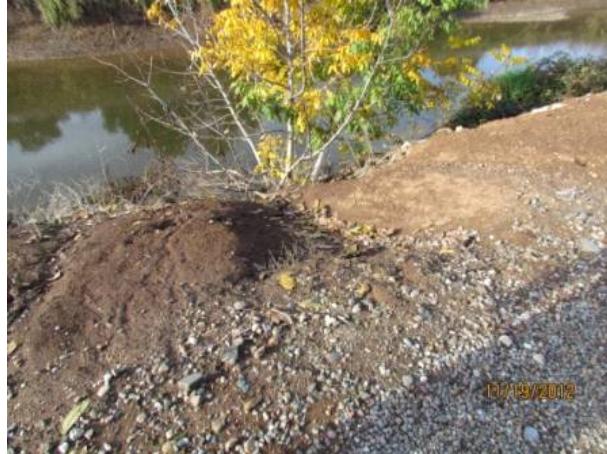
Levee Mile Report Line	27
Start Levee Mile	2.42
End Levee Mile	2.42
Location	Water Side
Category	Earthen Levee
Item	Slope Stability
Updated picture of the slope instability on the waterside shoulder of the levee looking upstream.	
pkazi_f_20131001_518.jpg

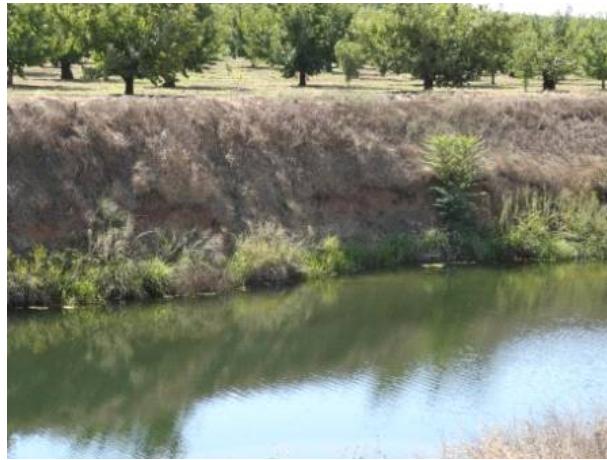
Levee Mile Report Line	32
Start Levee Mile	3.00
End Levee Mile	3.06
Location	Water Side
Category	Supplemental
Item	DWR Erosion Survey
Front view of erosion.	
SJR2013_NA0017U16RM20_2.jpg

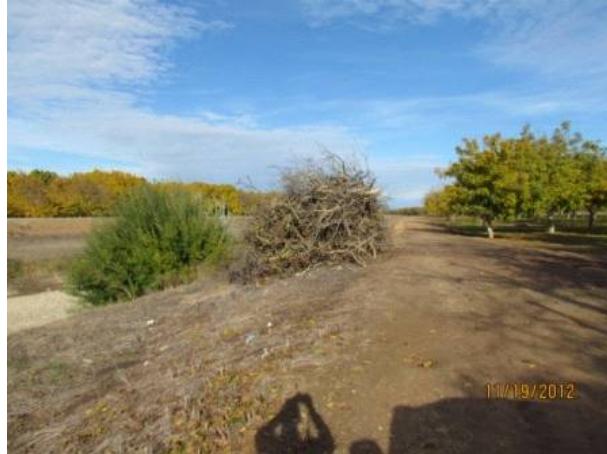
DWR ID:	
33	3.35	3.35	Earthen Levee	Encroachments	WS En	M	PR : Prunings Inspector Comments: Burn pile has been burned but new material has been placed.			38.023257 °	38.023257 ° 52
										-121.058158 °	-121.058158 ° Y
										DWR ID: DWR_NA0017_16_s_2012_52	
34	3.52	3.52	Earthen Levee	Encroachments	WS Ma	M	PR : Prunings Inspector Comments: Burn pile has been burned but new material has been placed.			38.021650 °	38.021650 ° 53
										-121.060312 °	-121.060312 ° Y
										DWR ID: DWR_NA0017_16_s_2012_53	
35	3.59	3.59	Earthen Levee	Vegetation	WS Ma	M	V2 : Remove the wild growth other than native grasses from the levee slopes.			38.020965 °	38.020965 ° 152
										-121.061215 °	-121.061215 ° Y
										DWR ID: DWR_NA0017_16_f_2013_152	
36	3.65	3.65	Earthen Levee	Erosion / Bank Caving	WS Ma	M	E2 : Schedule repair of erosion site prior to the next inspection.			38.020433 °	38.020433 ° 230

Levee Mile Report Line	33
Start Levee Mile	3.35
End Levee Mile	3.35
Location	Water Side
Category	Earthen Levee
Item	Encroachments
Prunings were found on the waterside shoulder of the levee looking upstream.	
<i>pkazi_f_20131001_419.jpg</i>

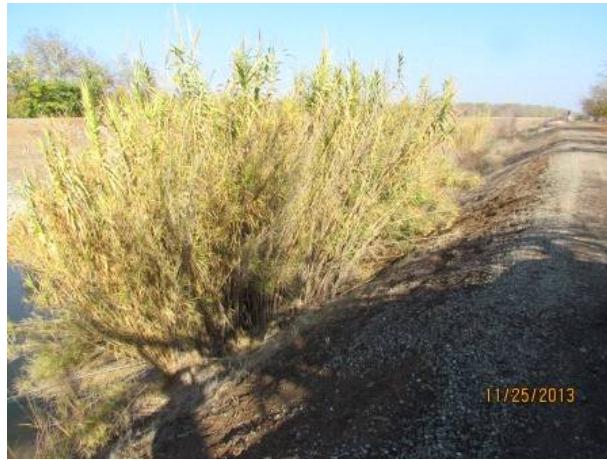
Levee Mile Report Line	35
Start Levee Mile	3.59
End Levee Mile	3.59
Location	Water Side
Category	Earthen Levee
Item	Vegetation
Arundo was found on the waterside toe of the levee looking upstream.	
<i>pkazi_f_20131126_093.JPG</i>

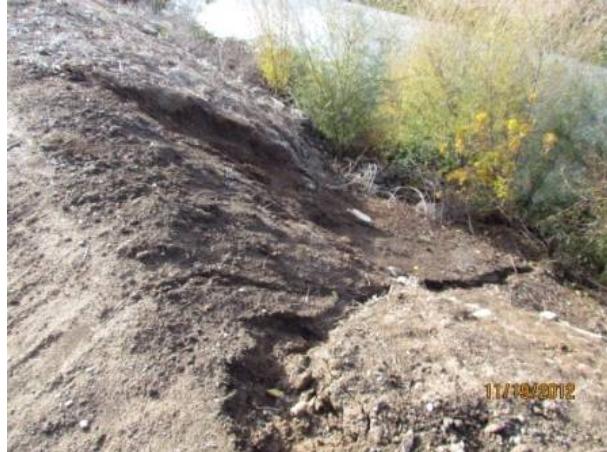
Levee Mile Report Line	36
Start Levee Mile	3.65
End Levee Mile	3.65
Location	Water Side
Category	Earthen Levee
Item	Erosion / Bank Caving
Slope instability was found on the waterside slope of the levee looking downstream.	
pkazi_f_20131001_521.jpg

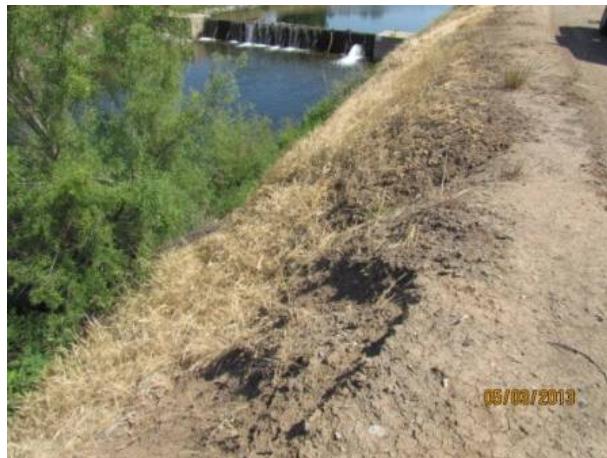
Levee Mile Report Line	36
Start Levee Mile	3.65
End Levee Mile	3.65
Location	Water Side
Category	Earthen Levee
Item	Erosion / Bank Caving
Erosion was found on the waterside slope of the levee looking upstream.	
pkazi_f_20131001_522.JPG

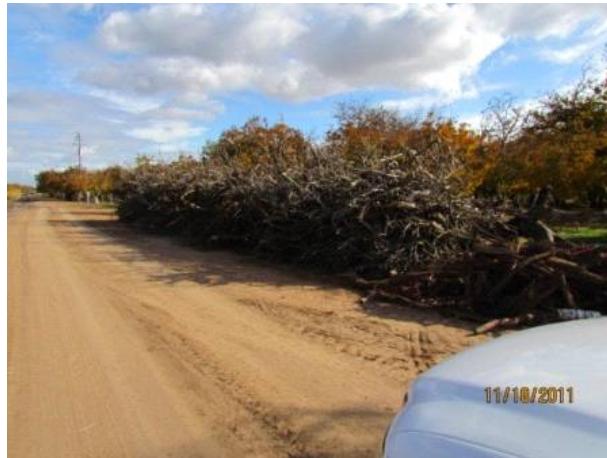
Levee Mile Report Line	37
Start Levee Mile	3.66
End Levee Mile	3.66
Location	Land Side
Category	Earthen Levee
Item	Encroachments
Prunings were found on the landside of the levee looking upstream.	
pkazi_f_20131001_516.jpg

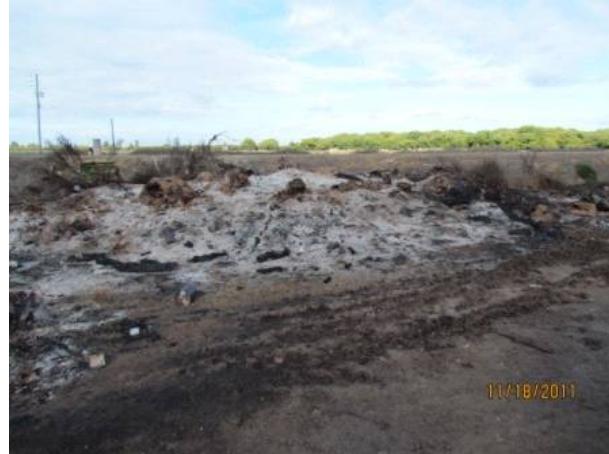
Levee Mile Report Line	40
Start Levee Mile	3.78
End Levee Mile	3.78
Location	Water Side
Category	Earthen Levee
Item	Encroachments
Prunings were found on the waterside of the levee looking upstream.	
<i>pkazi_f_20131001_421.jpg</i>

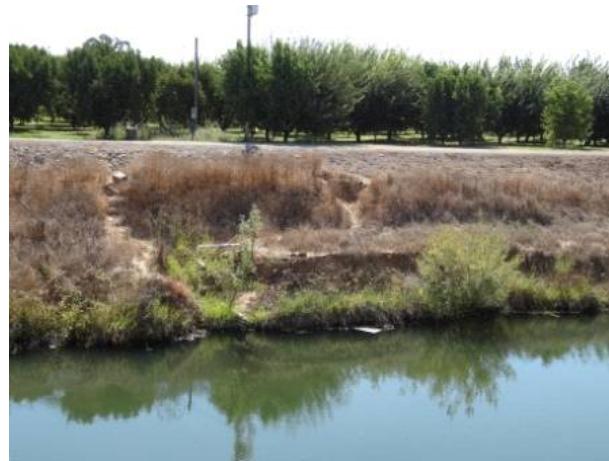
Levee Mile Report Line	43
Start Levee Mile	3.89
End Levee Mile	3.91
Location	Water Side
Category	Supplemental
Item	DWR Erosion Survey
Closer view at the erosion.	
<i>SJR2013_NA0017U16RM19.18_2.jpg</i>

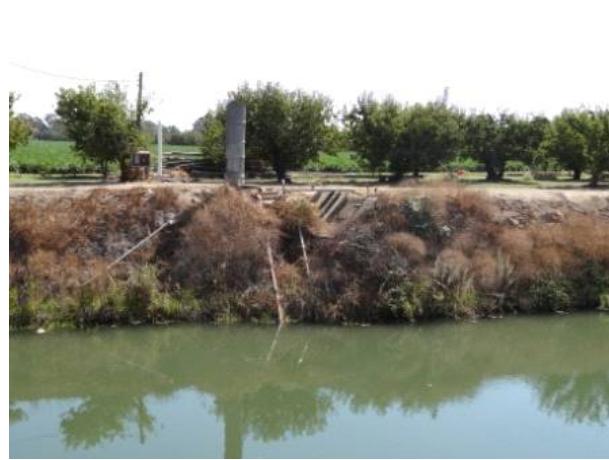
Levee Mile Report Line	46
Start Levee Mile	4.32
End Levee Mile	4.34
Location	Water Side
Category	Supplemental
Item	DWR Erosion Survey
Front view of erosion.	
<i>SJR2013_NA0017U16RM18.69_2.jpg</i>

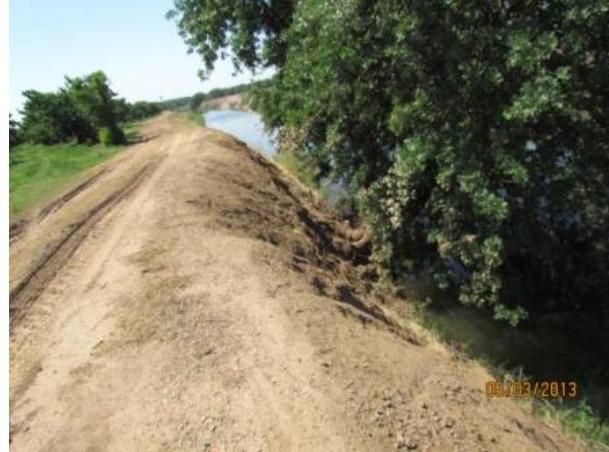
Levee Mile Report Line	48
Start Levee Mile	4.34
End Levee Mile	4.34
Location	Water Side
Category	Earthen Levee
Item	Slope Stability
Slope instability was found on the waterside shoulder of the levee looking downstream.	
pkazi_f_20131001_520.JPG

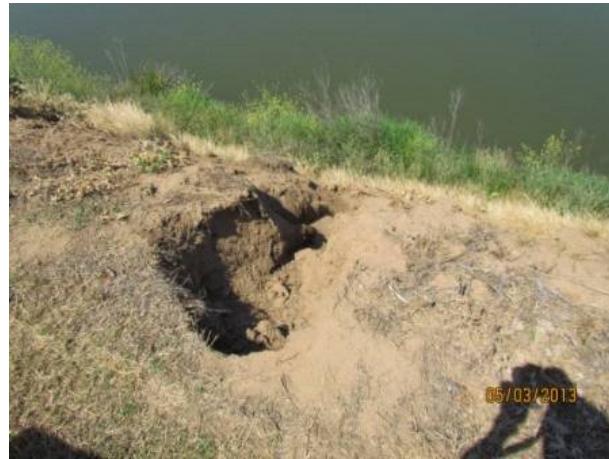
Levee Mile Report Line	49
Start Levee Mile	4.43
End Levee Mile	4.43
Location	Water Side
Category	Earthen Levee
Item	Erosion / Bank Caving
Erosion was found on the waterside shoulder of the levee looking downstream.	
pkazi_f_20131001_434.JPG

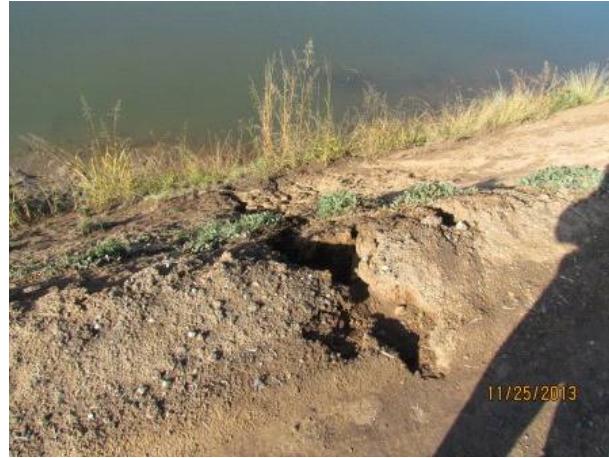
Levee Mile Report Line	49
Start Levee Mile	4.43
End Levee Mile	4.43
Location	Water Side
Category	Earthen Levee
Item	Erosion / Bank Caving
Updated picture of the erosion on the waterside of the levee looking upstream.	
pkazi_f_20131126_092.JPG

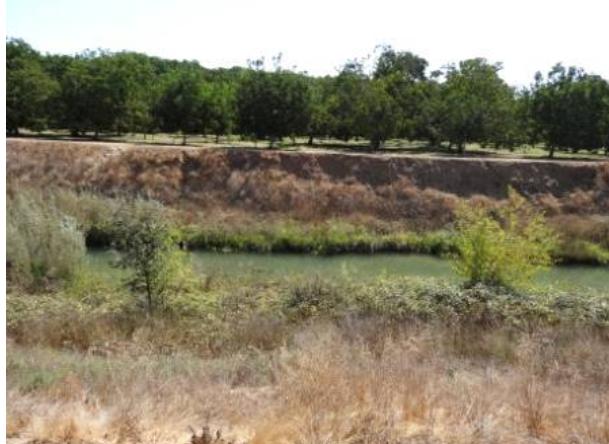
SJR2013\_NA0017U16RM17.99\_1.jpg

Levee Mile Report Line	52
Start Levee Mile	5.03
End Levee Mile	5.03
Location	Water Side
Category	Supplemental
Item	DWR Erosion Survey

View from right river bank.

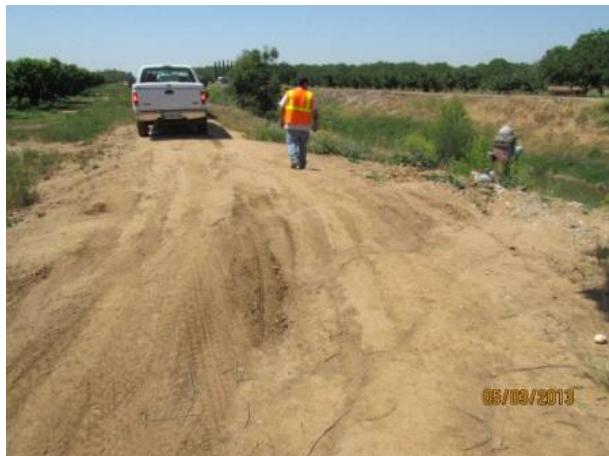
pkazi\_f\_20131001\_443.JPG

Levee Mile Report Line	53
Start Levee Mile	5.20
End Levee Mile	5.20
Location	Crown
Category	Earthen Levee
Item	Crown Surface / Depressions / Rutting

A pipe was running on top of the levee crown looking downstream. It appears to have 6 inches of soil cover over the pipe.

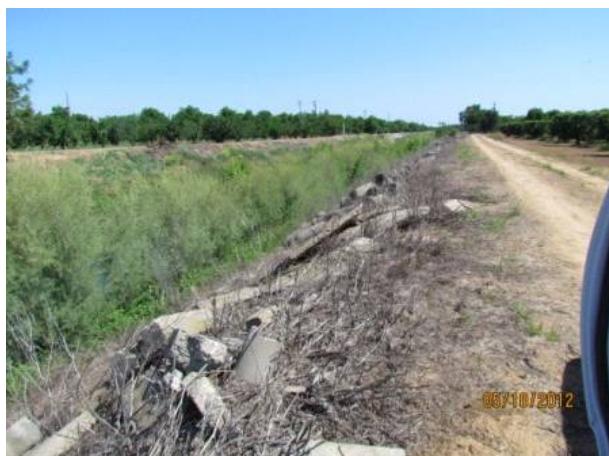
pkazi\_f\_20131001\_508.jpg

Levee Mile Report Line	54
Start Levee Mile	5.21
End Levee Mile	5.32
Location	Water Side
Category	Earthen Levee
Item	Encroachments

Debris was found on the waterside of the levee looking upstream.

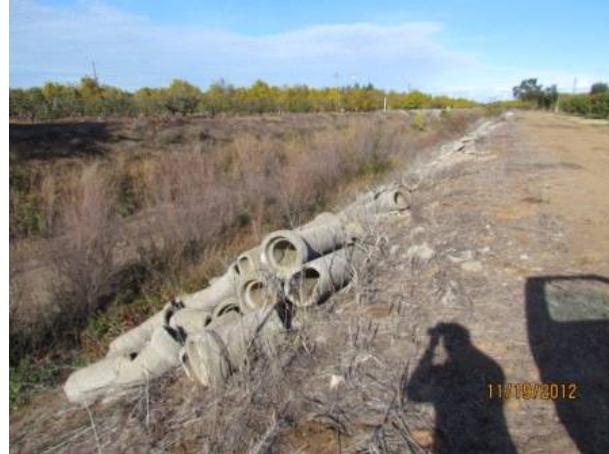
Levee Mile Report Line	54
Start Levee Mile	5.21
End Levee Mile	5.32
Location	Water Side
Category	Earthen Levee
Item	Encroachments
Concrete debris was found on the waterside slope of the levee looking upstream.	
pkazi_f_20131001_509.jpg

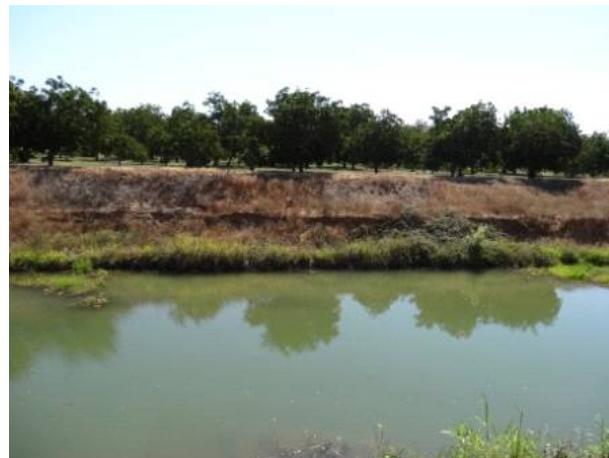
Levee Mile Report Line	57
Start Levee Mile	5.52
End Levee Mile	5.57
Location	Water Side
Category	Supplemental
Item	DWR Erosion Survey
Front view of the site.	
SJR2013_NA0017U16RM17.81_2.jpg

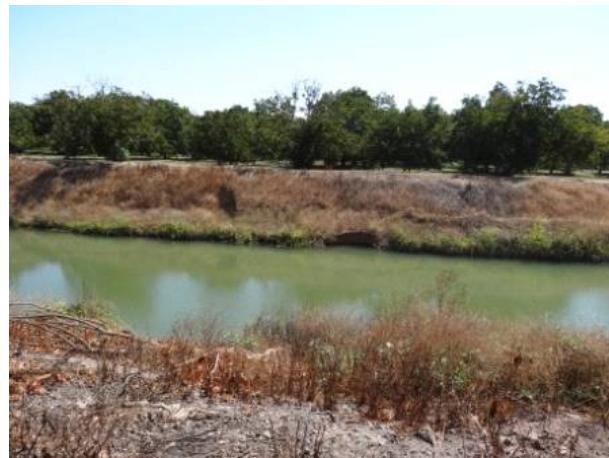
Levee Mile Report Line	58
Start Levee Mile	5.55
End Levee Mile	5.57
Location	Water Side
Category	Supplemental
Item	DWR Erosion Survey
Looking from right river bank.	
SJR2013_NA0017U16RM17.27_1.jpg

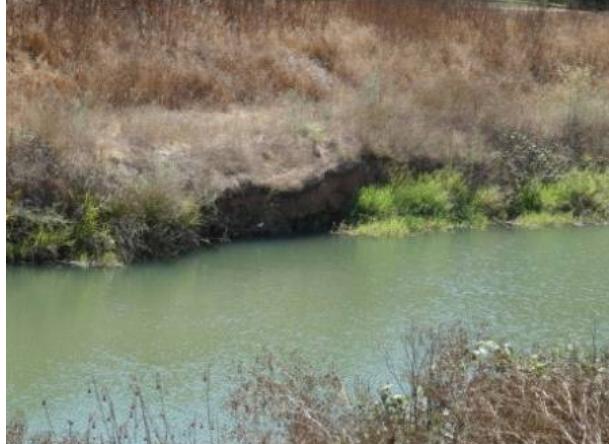
SJR2013_NA0017U16RM17.27_2.jpg

Levee Mile Report Line	58
Start Levee Mile	5.55
End Levee Mile	5.57
Location	Water Side
Category	Supplemental
Item	DWR Erosion Survey
Looking from right river bank.

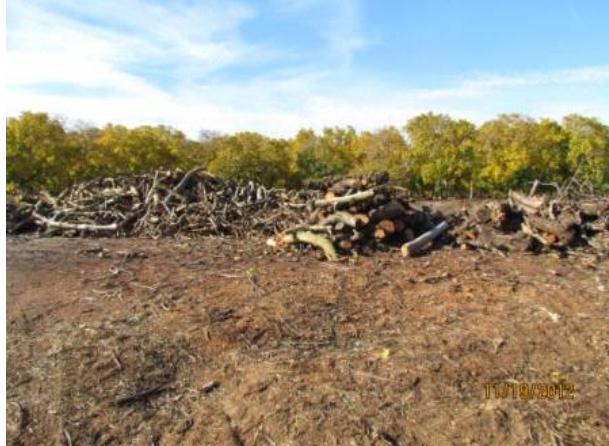
pkazi_f_20131001_422.jpg

Levee Mile Report Line	59
Start Levee Mile	5.83
End Levee Mile	5.83
Location	Water Side
Category	Earthen Levee
Item	Encroachments
Prunings were found on the waterside shoulder of the levee looking upstream.

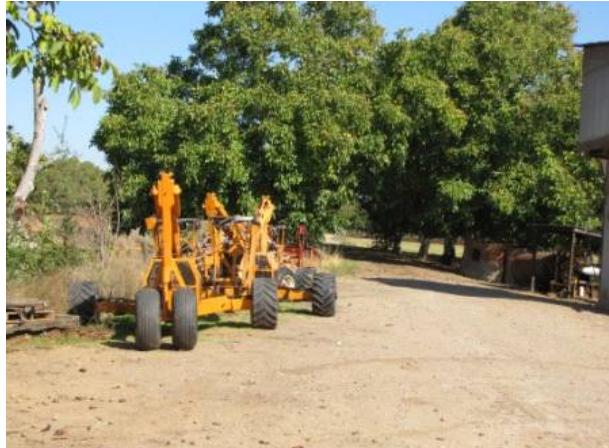
pkazi_f_20131001_498.jpg

Levee Mile Report Line	61
Start Levee Mile	5.94
End Levee Mile	5.94
Location	Water Side
Category	Earthen Levee
Item	Encroachments
View of equipment located on the waterward side looking upstream.

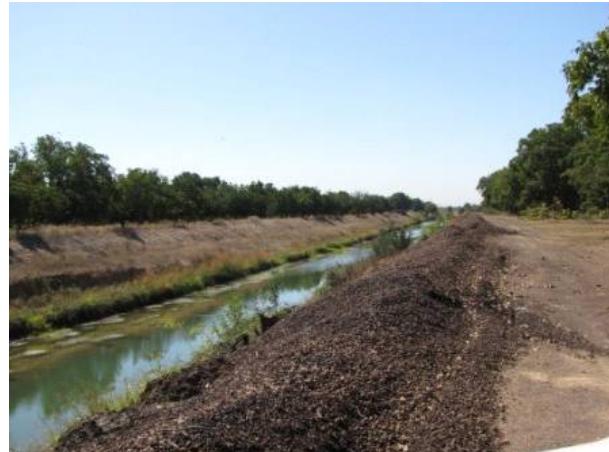
Levee Mile Report Line	69
Start Levee Mile	6.32
End Levee Mile	6.32
Location	Water Side
Category	Earthen Levee
Item	Encroachments
View of a large prunings pile on waterward side and access road blocking visibility and access looking upstream.	
pkazi_f_20131001_423.jpg

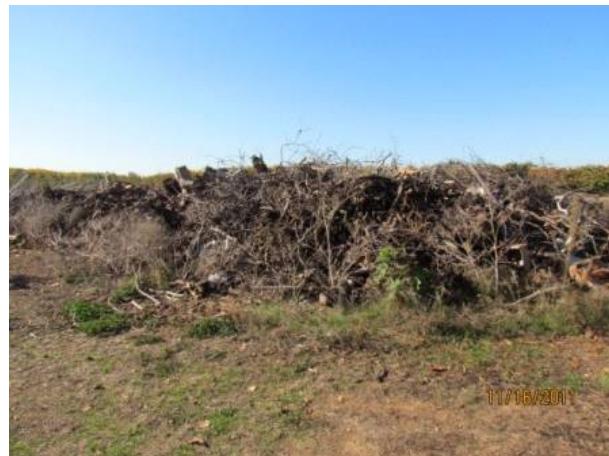
Levee Mile Report Line	69
Start Levee Mile	6.32
End Levee Mile	6.32
Location	Water Side
Category	Earthen Levee
Item	Encroachments
Prunings were found on the waterside of the levee looking upstream. This picture was taken during fall 2011 inspection.	
pkazi_f_20131001_424.jpg

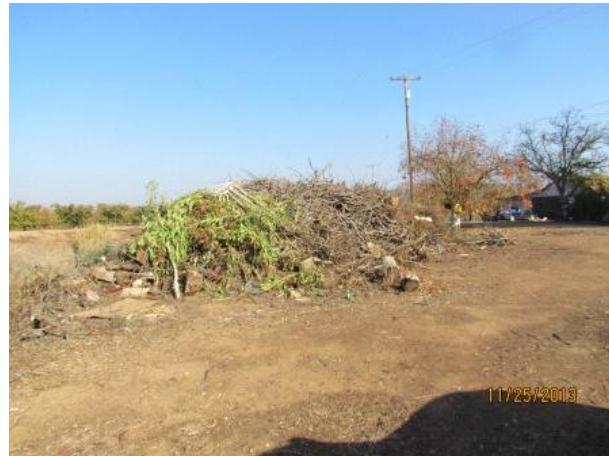
Levee Mile Report Line	69
Start Levee Mile	6.32
End Levee Mile	6.32
Location	Water Side
Category	Earthen Levee
Item	Encroachments
View of the prunings pile on the waterside shoulder of the levee looking upstream during fall 2013 inspection.	
pkazi_f_20131126_091.JPG

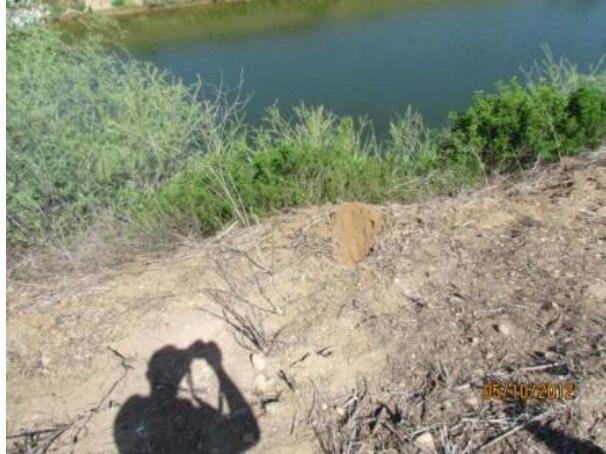
Levee Mile Report Line	70
Start Levee Mile	6.35
End Levee Mile	6.35
Location	Water Side
Category	Earthen Levee
Item	Animal Control
An animal hole was found on the waterside of the levee looking upstream.	
pkazi_f_20131001_497.jpg

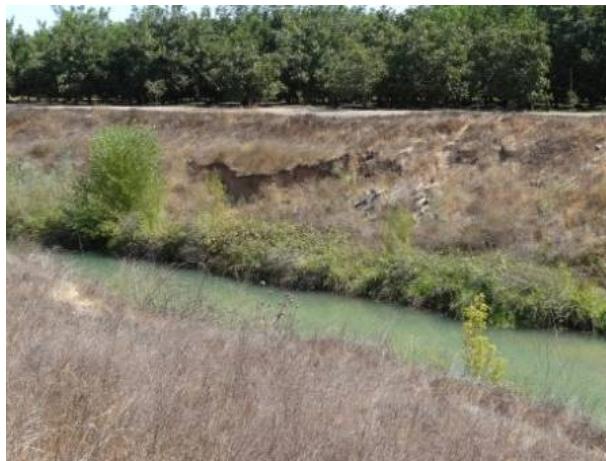
Levee Mile Report Line	72
Start Levee Mile	6.72
End Levee Mile	6.91
Location	Water Side
Category	Supplemental
Item	DWR Erosion Survey
Looking at the upstream end of erosion site.	
SJR2013_NA0017U16RM16.27_1.jpg

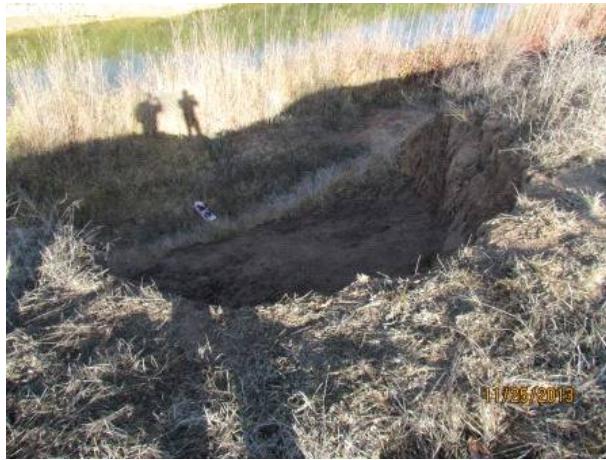
Levee Mile Report Line	73
Start Levee Mile	6.82
End Levee Mile	6.82
Location	Water Side
Category	Earthen Levee
Item	Erosion / Bank Caving
Erosion was found on the waterside slope of the levee looking upstream.	
pkazi_f_20131126_090.JPG

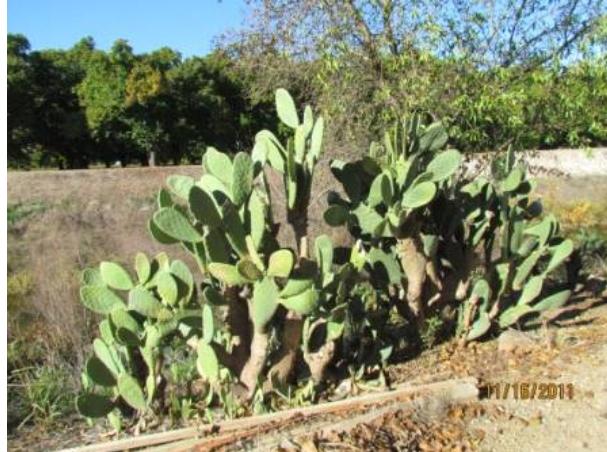
Levee Mile Report Line	75
Start Levee Mile	7.01
End Levee Mile	7.01
Location	Water Side
Category	Earthen Levee
Item	Vegetation
Cacti were found on the waterside of the levee looking upstream.	
pkazi_f_20131001_425.jpg

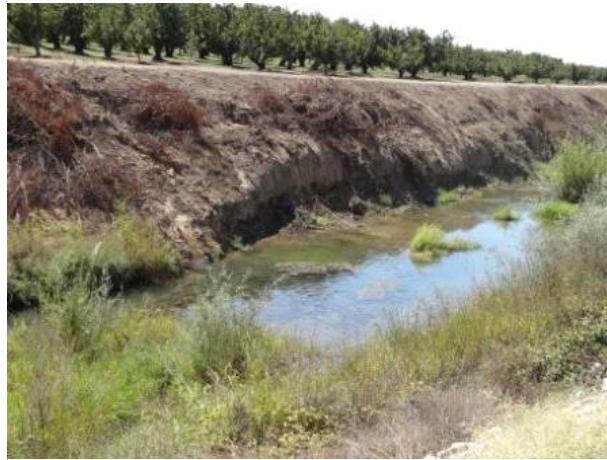
Levee Mile Report Line	78
Start Levee Mile	7.35
End Levee Mile	7.41
Location	Water Side
Category	Supplemental
Item	DWR Erosion Survey
Close view of erosion.	
SJR2013_NA0017U16RM10.82_2.jpg

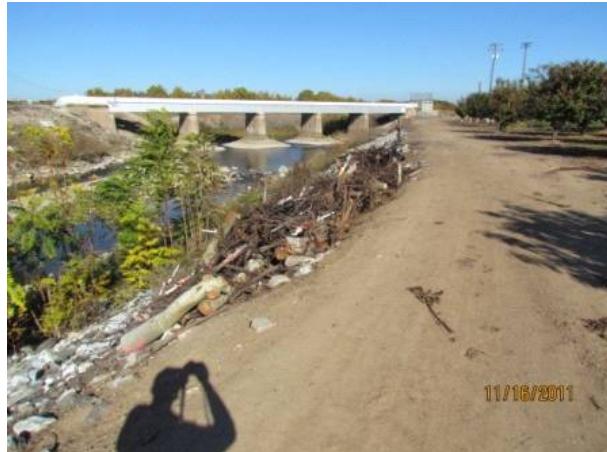
Levee Mile Report Line	79
Start Levee Mile	7.37
End Levee Mile	7.37
Location	Water Side
Category	Earthen Levee
Item	Encroachments
Debris and prunings were found on the waterside of the levee looking upstream.	
pkazi_f_20131001_426.jpg

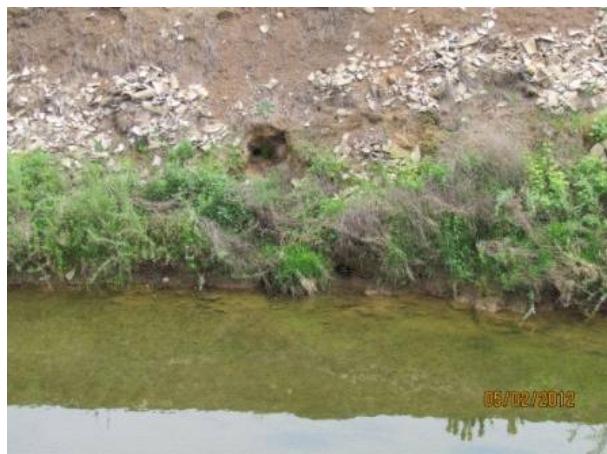
Levee Mile Report Line	81
Start Levee Mile	7.57
End Levee Mile	7.57
Location	Water Side
Category	Earthen Levee
Item	Animal Control
A possible beaver den was found on waterside slope of the levee. The picture was taken from the opposite bank of the levee.	
pkazi_f_20131001_519.jpg

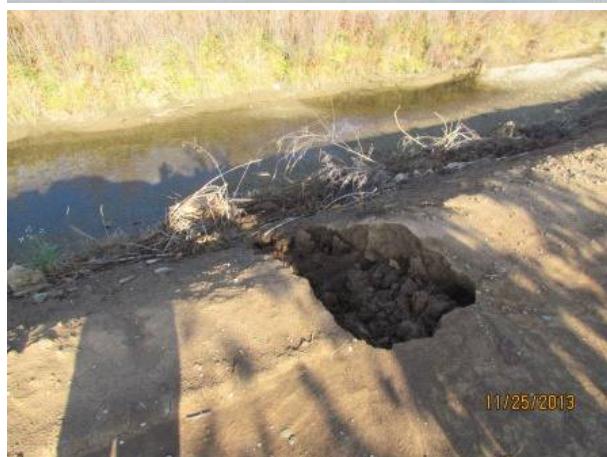
Levee Mile Report Line	82
Start Levee Mile	7.63
End Levee Mile	7.63
Location	Water Side
Category	Earthen Levee
Item	Erosion / Bank Caving
Erosion due to runoff was found on the waterside shoulder of the levee looking upstream.	
pkazi_f_20131126_088.JPG

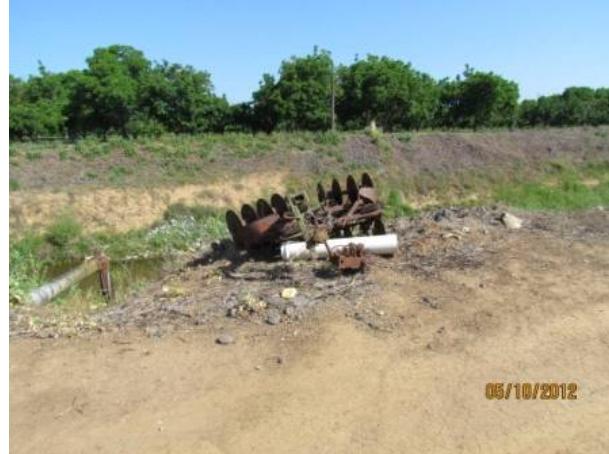
Levee Mile Report Line	83
Start Levee Mile	7.68
End Levee Mile	7.68
Location	Water Side
Category	Earthen Levee
Item	Encroachments
Equipment was found on the waterside of the levee looking upstream.	
pkazi_f_20131001_495.jpg

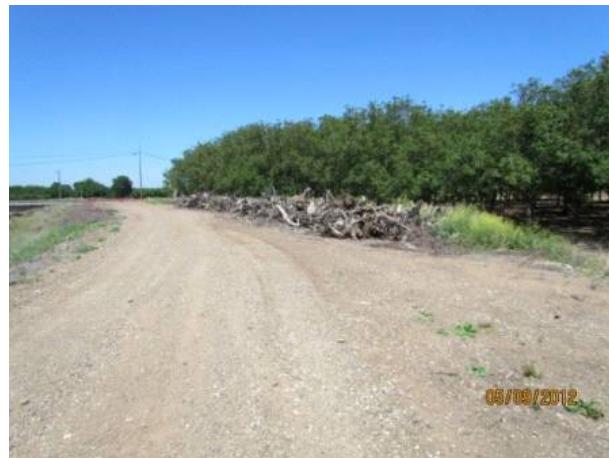
Levee Mile Report Line	87
Start Levee Mile	8.34
End Levee Mile	8.34
Location	Water Side
Category	Earthen Levee
Item	Encroachments
Prunings were found on the landside of the levee looking upstream.	
pkazi_f_20131001_444.jpg

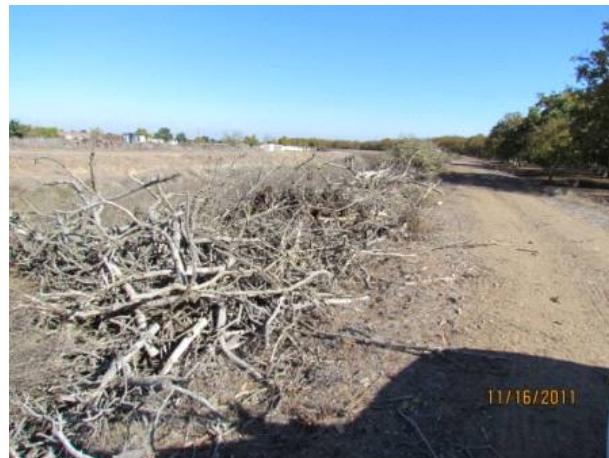
Levee Mile Report Line	89
Start Levee Mile	8.54
End Levee Mile	8.66
Location	Water Side
Category	Earthen Levee
Item	Encroachments
Prunings were found on the waterside of the levee looking upstream.	
pkazi_f_20131001_437.jpg

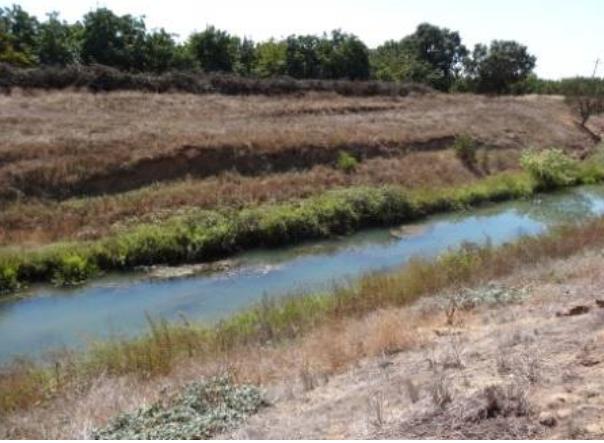
SJR2013\_NA0017U16RM14.48\_1.jpg

Levee Mile Report Line	90
Start Levee Mile	8.61
End Levee Mile	8.65
Location	Water Side
Category	Supplemental
Item	DWR Erosion Survey

Looking at the site from right river bank.
